Oliu-1, Armando
Monday, January 27, 2003 10:53 AM Abner, Charlie; Leinbach-1, Mike 8T8-107 Debris strike on wing

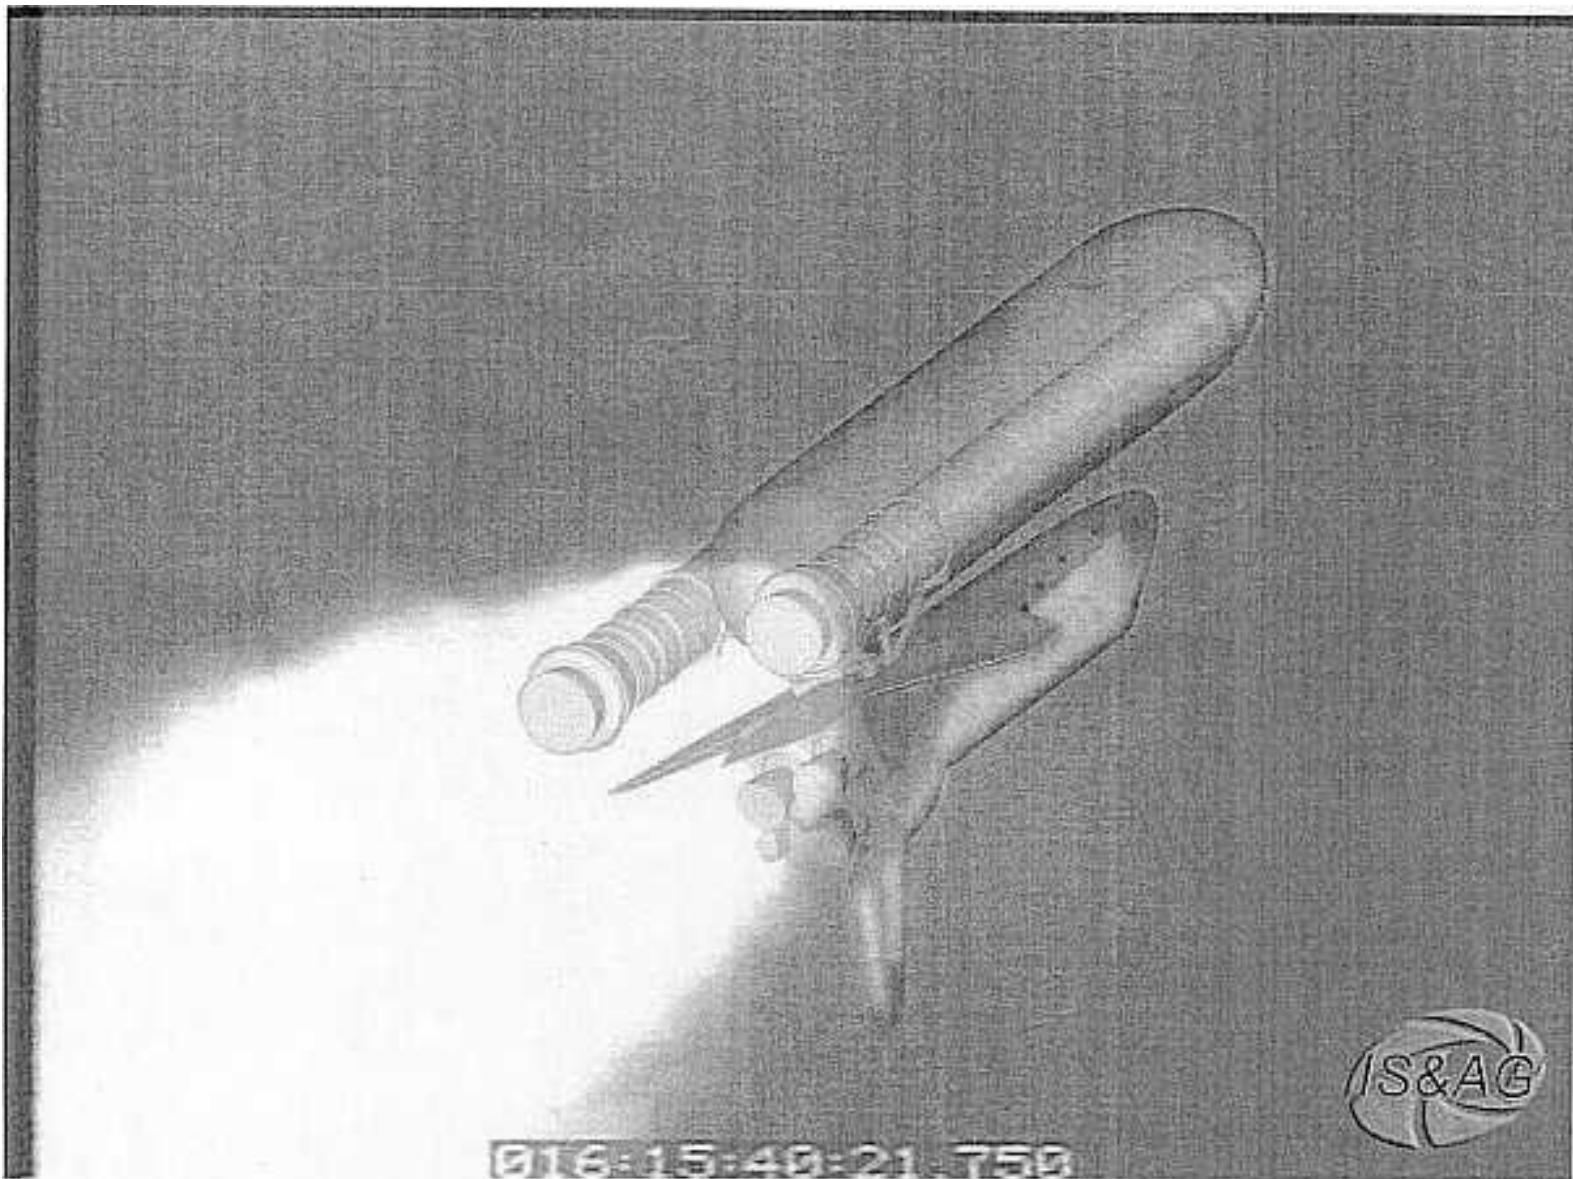
208_debris track_overlay2.jpg

Since there was some concern over whether or not the debris hit near the Main Landing Gear door, the JSC folks came w/ a good overlay photo showing the location of the hit in relation to the MLG door.

As we said in the film review, the hit appeared to be near the leading edge of the wing, in between RCC panels 7 and 10.
